BOILER ACCIDENT AT THE KURUNUI BATTERY, THAMES GOLD FIELD,

(ROYAL COMMISSION TO INQUIRE INTO THE, AND INTO THE MACHINERY AND BOILERS ON
THE FIELD GENERALLY).

REPORT.

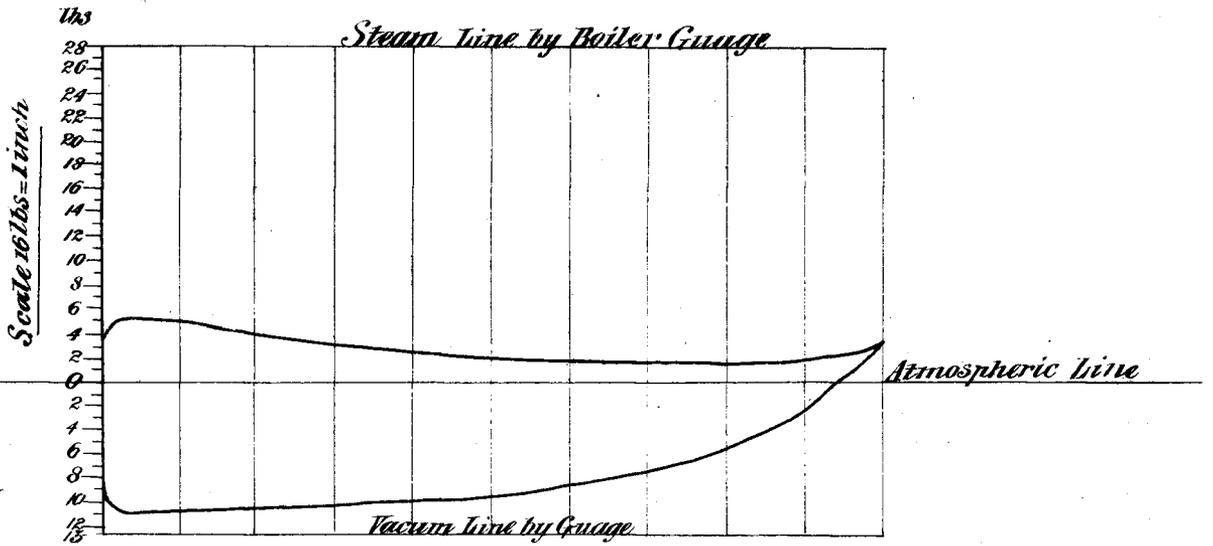
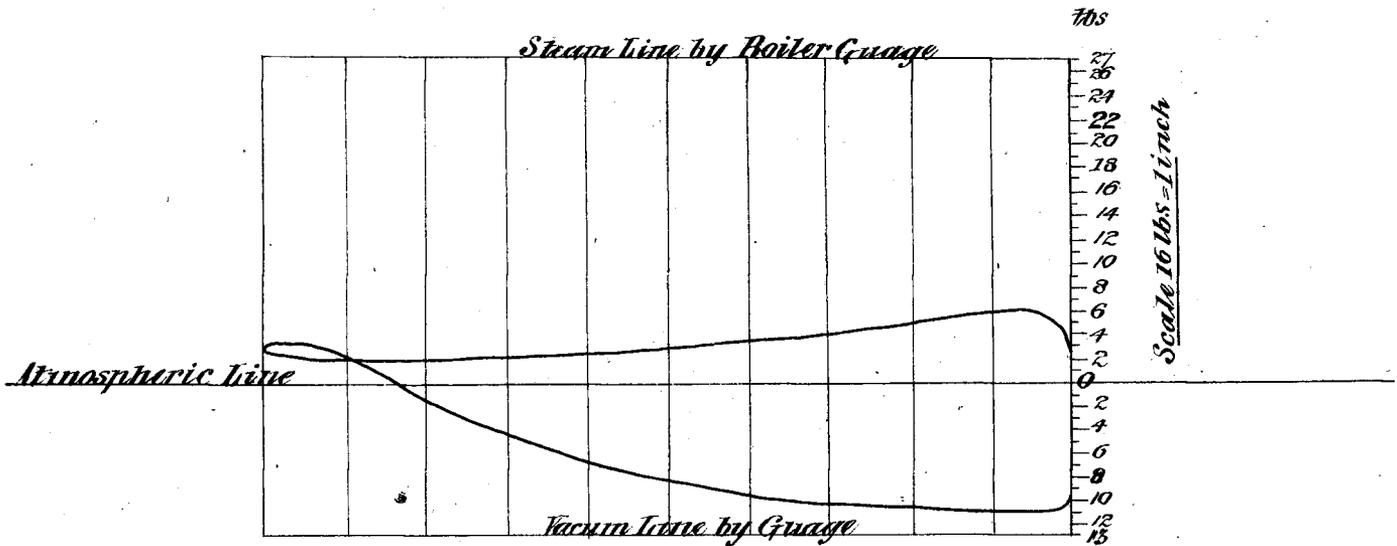
ENGINE DIAGRAMS KURANUI BATTERY

Forward Stroke $\frac{3}{4}$ power. Revolutions 25 per Min $\frac{1}{11}$

Indicating 37.2 HP

BACK STROKE $\frac{3}{4}$ power. Revolutions 22 per Min $\frac{1}{11}$

Cylinder $24\frac{1}{4}$ in diam:

Stroke $\frac{1}{2}$ ins

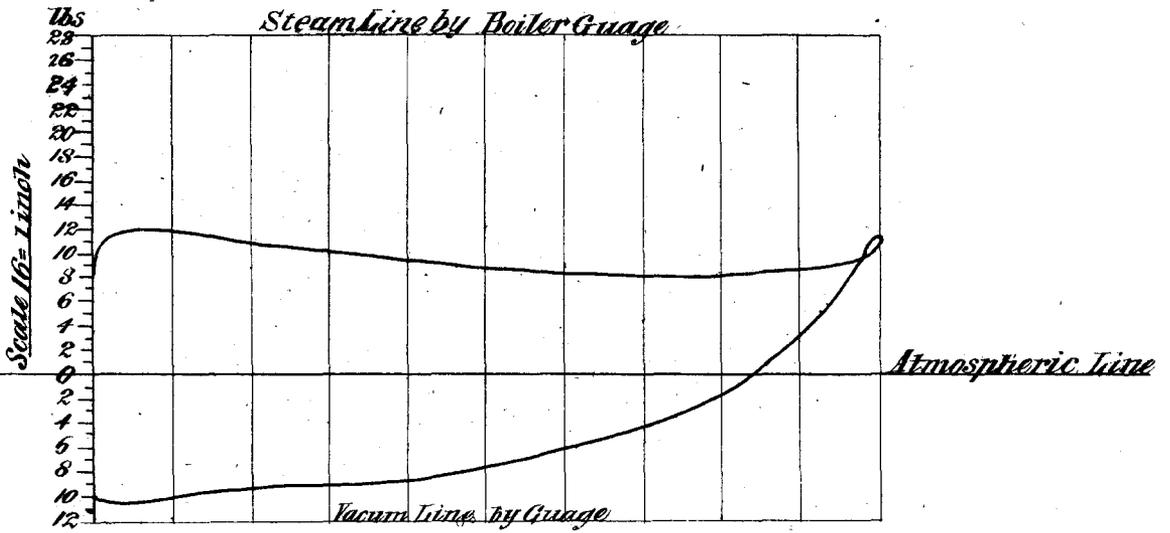
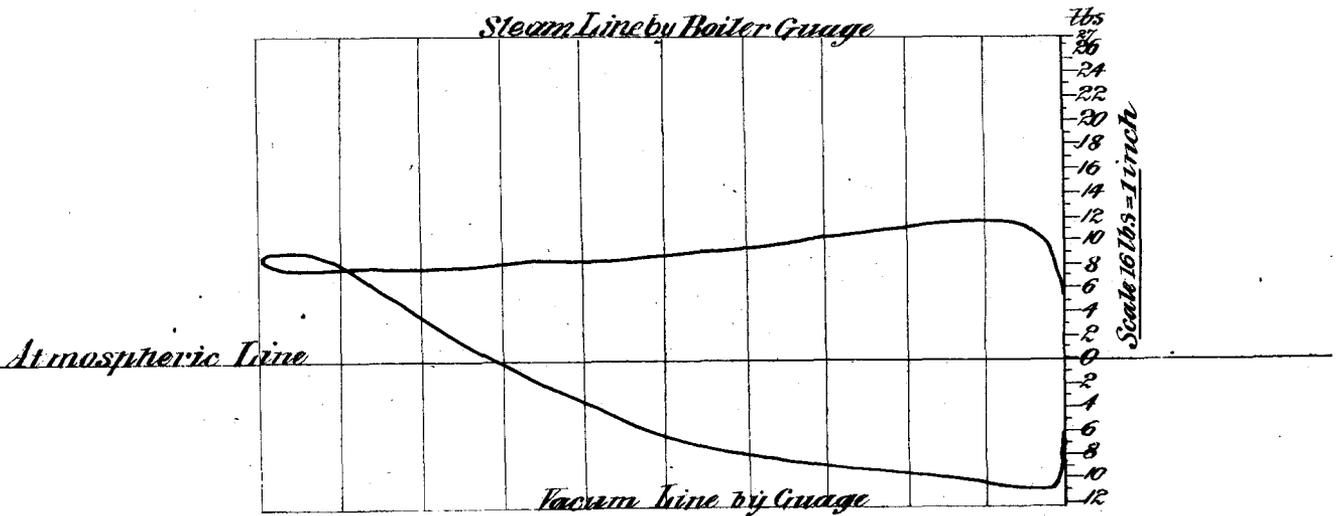
— ENGINE DIAGRAMS. KURANUI BATTERY —

FORWARD STROKE 22 Revolutions per Min^t

Indicating 56 HP

BACK STROKE 24 Revolutions per Min^t

Cylinder 24 1/2 ins diam:

Stroke 7/2 "
